East River, Chester Watershed  
Habitat Report

Bluenose Coastal Action Foundation

March 2016

## American eel (*Anguilla rostrata*) Habitat Surveys 2015

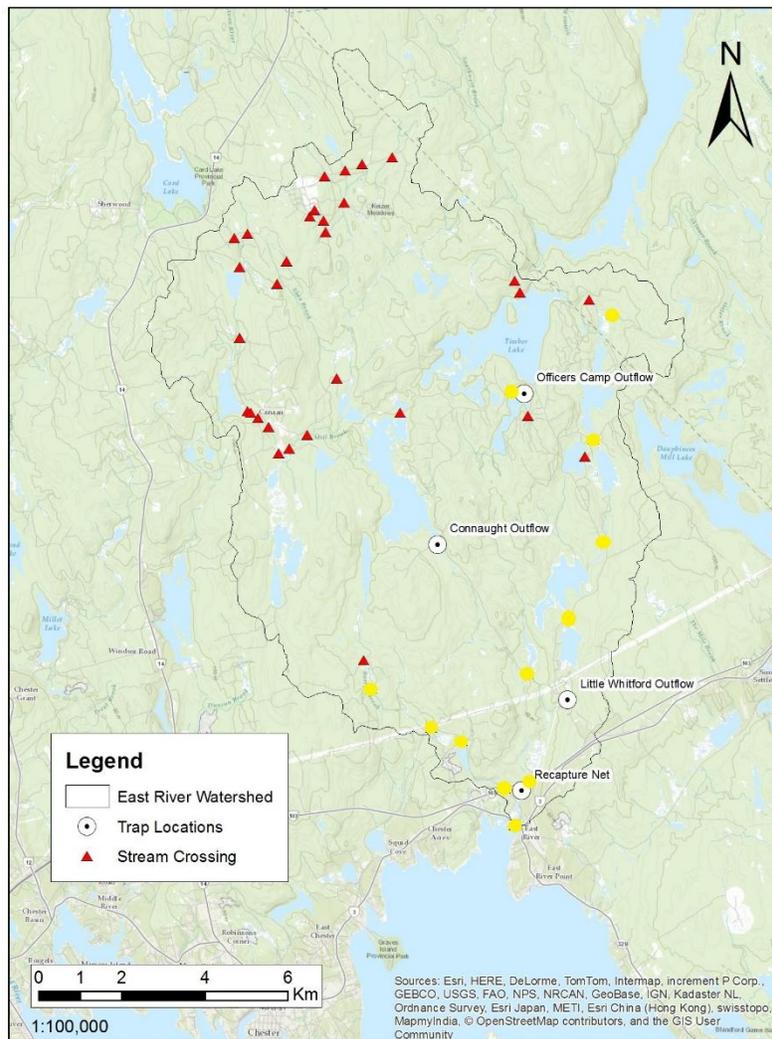
In 2015, potential barriers preventing eel migration throughout the East River watershed were examined using GIS, through road-waterway crossings. Potential barriers were prioritized, based on closeness to main river area, as well as amount of habitat gained. Six road crossings were identified as high priority of needing fish passage assessments, but several additional sites were also examined (Figure 2).

Figure 2: Map of all crossings within East River, Chester watershed (GIS BCAF 2015). Yellow indicates sites that were examined.

Upon examining each of the road crossings in 2015, it was determined that no further assessment would be necessary. As the land was formerly owned by Bowater Mersey, proper bridges were found to be in place, all with natural stream bottoms, ideal for fish passage, and no blockages to fish migration.

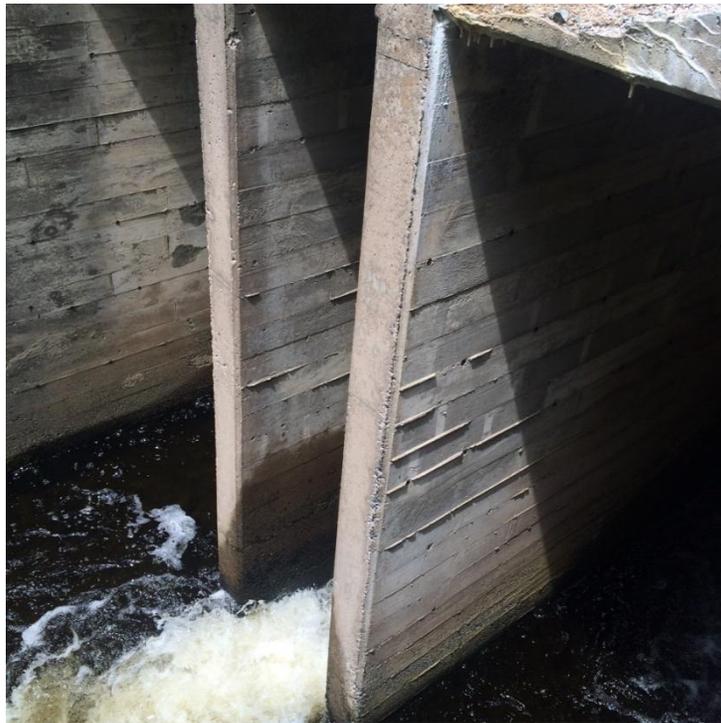
*Figure 3: View of flow control structure at Timber Lake (2015). Both the right and left sides are equipped with stop logs; a small opening in the center directs waterflow through at a high velocity.*

Because the land comprising most of the watershed was previously owned by Bowater Mersey, many dams and sluiceways had been in place historically, but have since been removed to allow fish passage. However, one exception remains at the outflow of Timber Lake, inhibiting fish passage upstream to the headwaters of the East River, into Timber and Officer Camp Lakes (Figures 3, 4, and 5).

Upon visiting this site on several occasions (monthly throughout July to October), fish were observed pooling in large numbers at the base of structure, swimming against the current in an attempt to swim upstream. Species observed included numerous small American eel, White Sucker, and Brook Trout.

Due to the extent of the size and type of structure, it was re-examined with NSLC Adopt-A-Stream Program staff, and deemed necessary to consult with a fish passage engineer to determine future directions. Additional funding would be required, as cost would likely be steep for not only a consultation, but also for construction of a fish passage structure, or alternatively removal of the structure. As well, due to a number of cottages surrounding Timber Lake, public consultation would be required as part of the process.

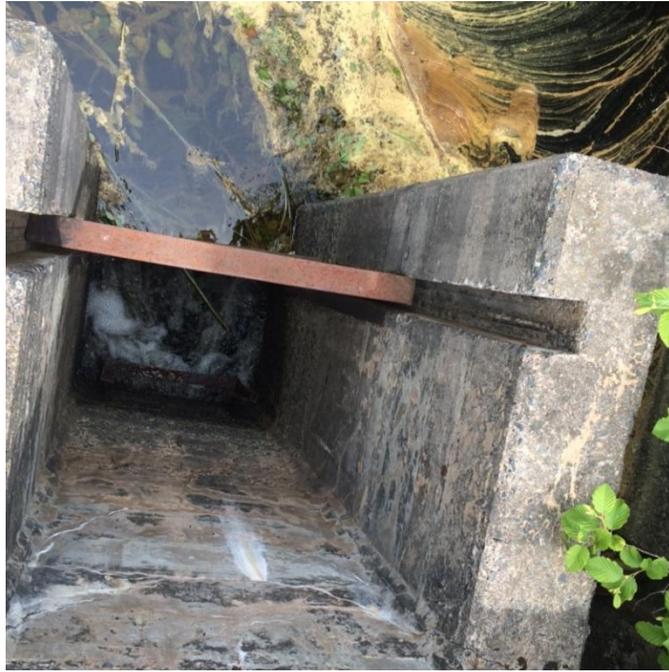
Figure 4: View from upstream center of Timber Lake flow control structure (2015).

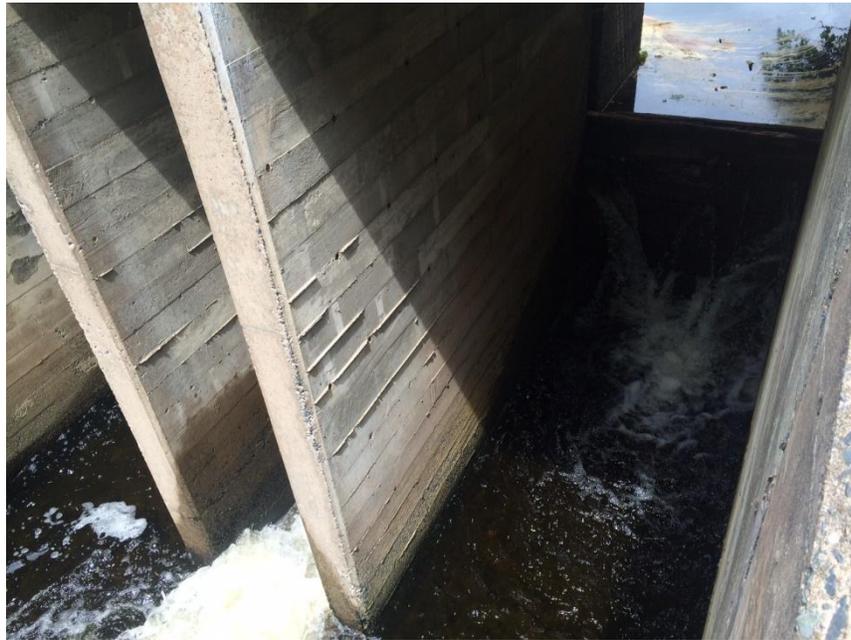
Figure 5: View from downstream looking upstream of Timber Lake flow control structure (2015). Note that the drop over the stop logs is about five feet. Many fish observed pooled on both sides below the stop logs.
